Manhole Inspection Summary

Manhole # S21KK_012MH

Insp Date: **6/1/07 9:12 AM**

Location Address: **1929 FULTON AVE**

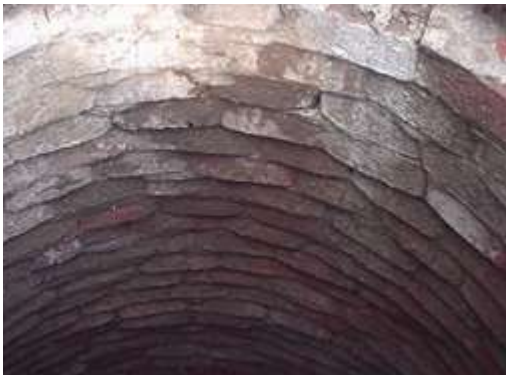
Defect 3

Infiltration: ☐ None ☐ Joint ☐ Cracks ☐ Mortar ☐ Roots ☒ **Wall**

CORBEL WALL INFILTRAZION

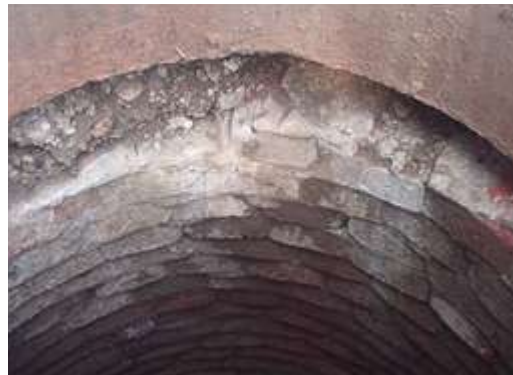
Defect 2

Condition: ☐ Sound ☐ Cracked ☐ Root Intrusion ☐ Loose Brick ☒ **Deteriorated**

CHIMNEY DETERIORATION

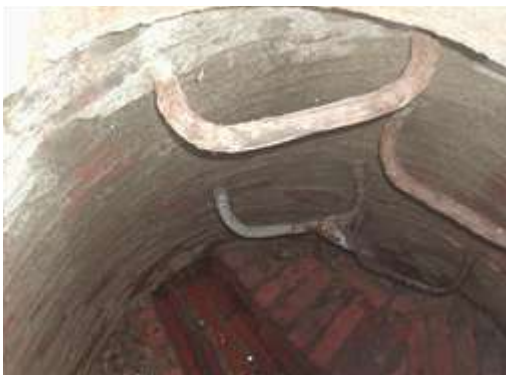
Defect 1

Steps Count: **4** Missing: **0** ☒ **Corroded**

CORRODED STEPS

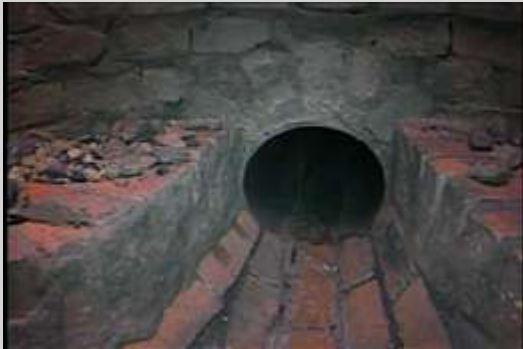
12 O'Clock Outflow

8 in. Circular Gravity Sewer
Pipe Out @ 12 O'Clock

Pipe Height: **7.2** (in.) Rod and Bar (Angled)
Pipe Material: **Clay** ☐ Pipe Lined
Invert Depth: **7.73** (ft.) Flow Characteristics: **Slow**
Deposits: ☒ None ☐ Mud ☐ Sludge ☐ Debris ☐ Grease
Silt Depth: (in.) Deposits Extent:
Infiltration: **None** Pipe Seal Cond: **Sound**

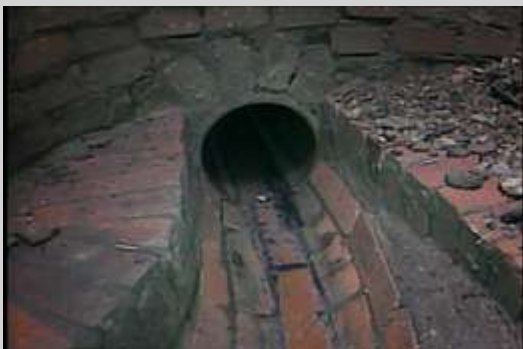
4 O'Clock Inflow

8 in. Circular Gravity Sewer
Pipe In @ 4 O'Clock

Pipe Height: **8.4** (in.) Rod and Bar (Angled)
Pipe Material: **Clay** ☐ Pipe Lined
Invert Depth: **7.68** (ft.) Flow Characteristics: **Slow**
Deposits: ☒ None ☐ Mud ☐ Sludge ☐ Debris ☐ Grease
Silt Depth: (in.) Deposits Extent:
Infiltration: **None** Pipe Seal Cond: **Sound**

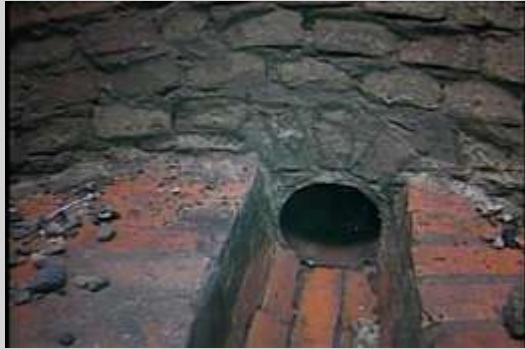
8 O'Clock Inflow

6 in. Circular Gravity Sewer

Pipe In @ 8 O'Clock

Pipe Height: **6** (in.) Rod and Bar (Angled)

Invert Depth: **7.54** (ft.) Flow Characteristics: **None**

Infiltration: **None**

Pipe Seal Cond: **Sound**
